USF Report No. 12.22.1304

Building Damage Evaluation

**Location of Loss:
Ramey Residential Building
24 Michigan Street
Long Beach, New York 11561-1309**

Claim No. 12-13381

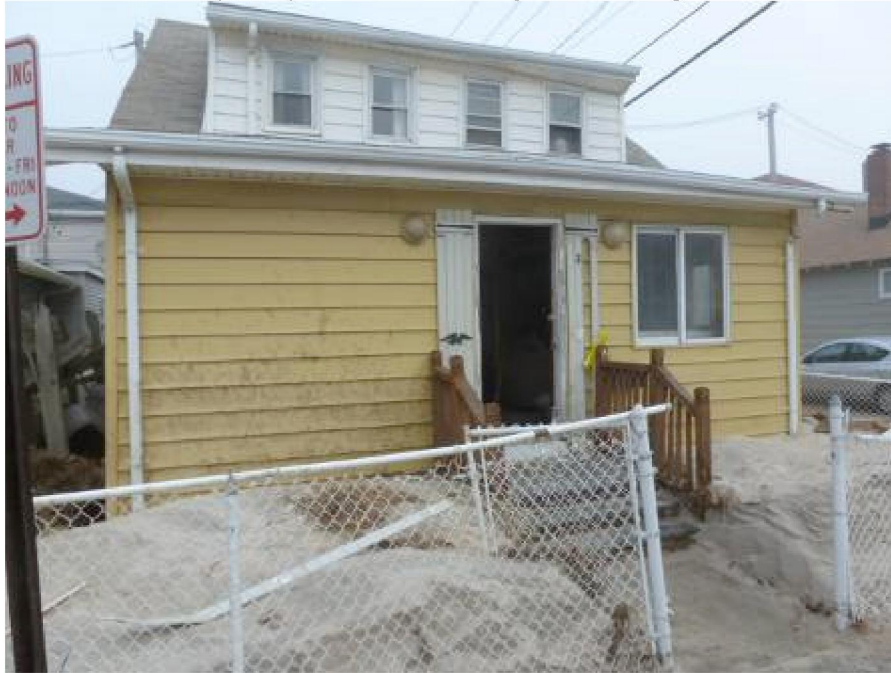
Photograph 1

View of the front (west) side of the subject building.

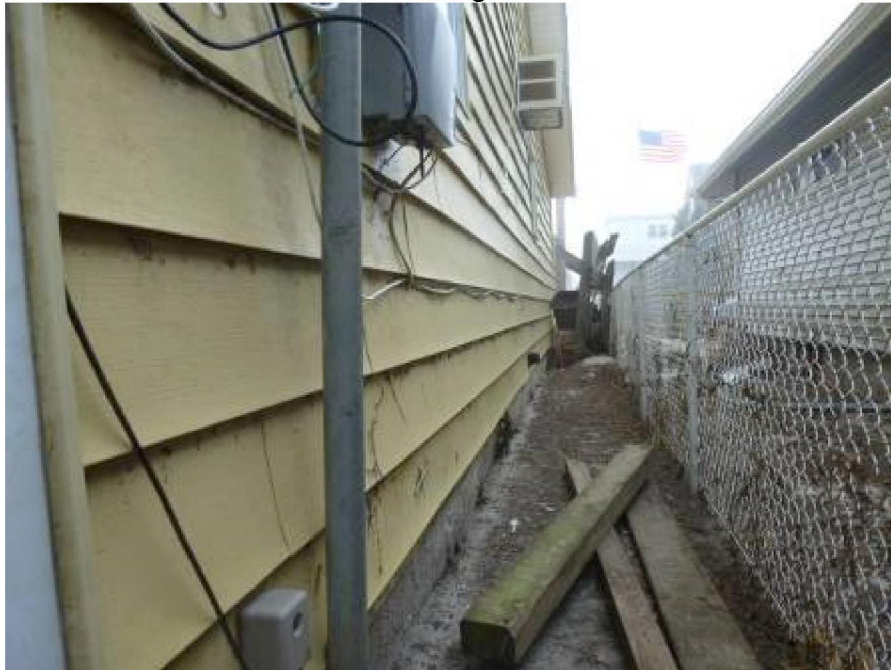
Photograph 2

View of the north side of the building.

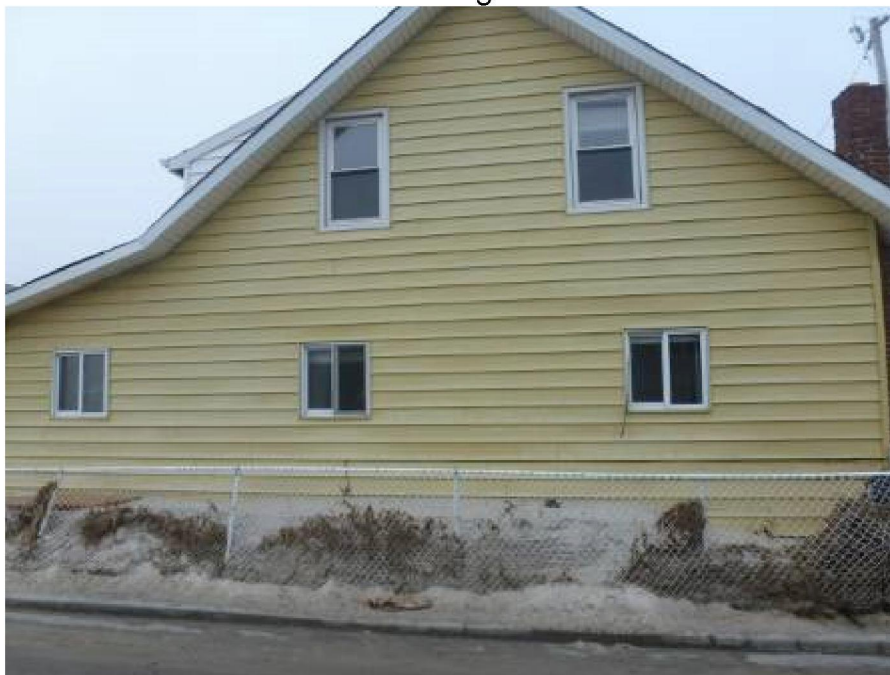
Photograph 3
View of the south side of the building.

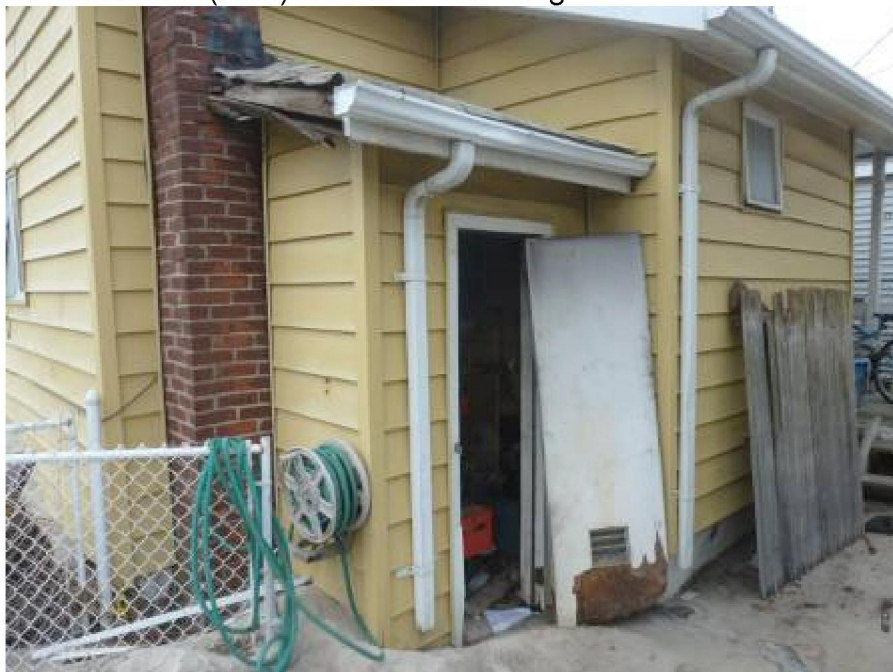
Photograph 4
View of the rear (east) side of the building.

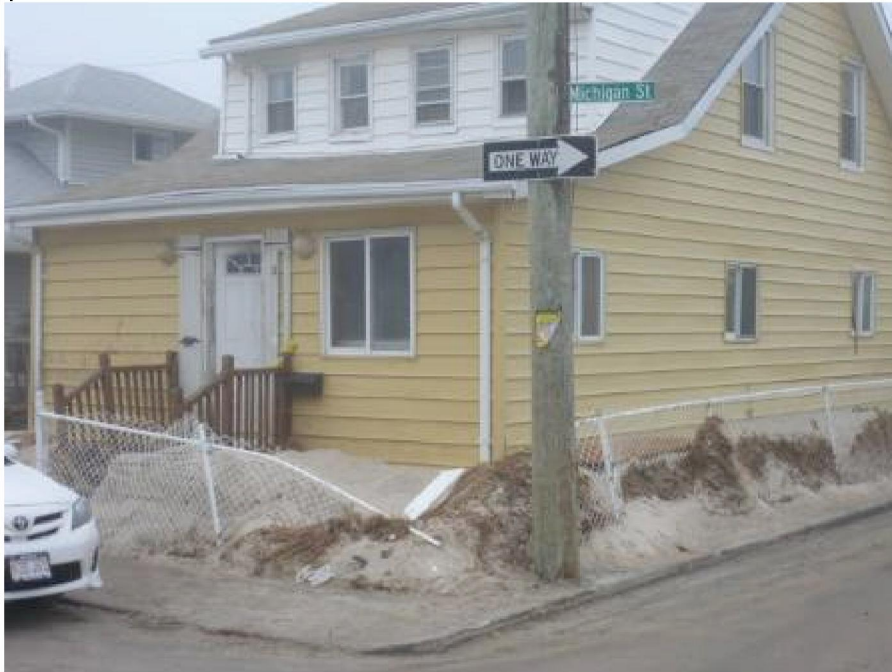
Photograph 5

View of the south-west corner of the building. Note the waterborne deposits of sand.

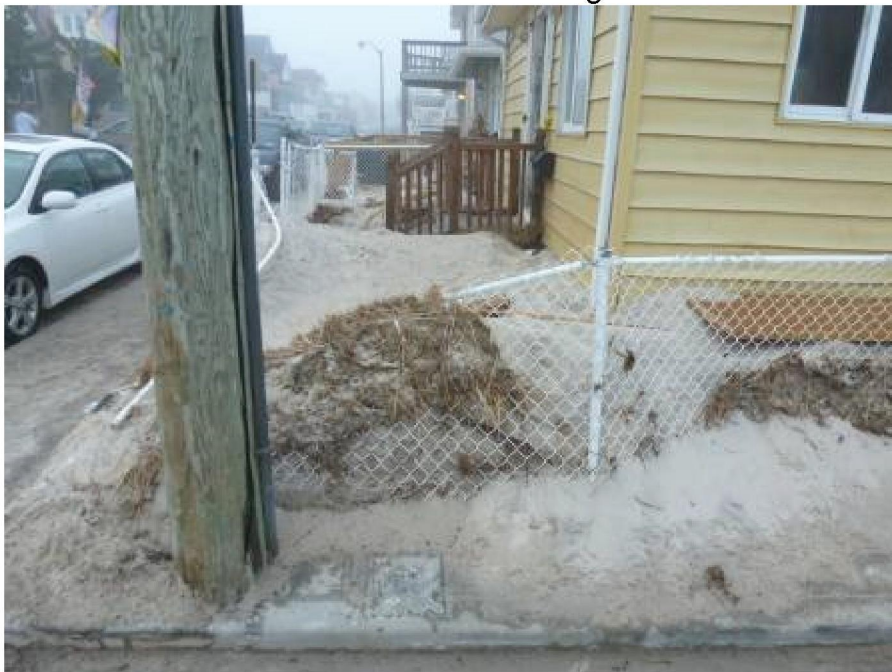
Photograph 6

View of the south-west corner of the building.

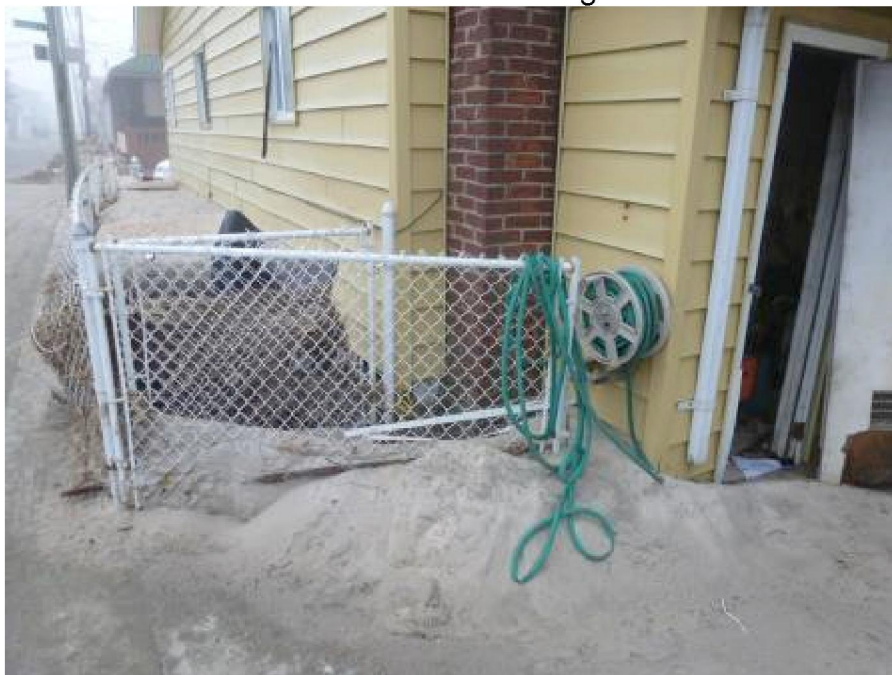
Photograph 7

View of the south-east corner of the building.

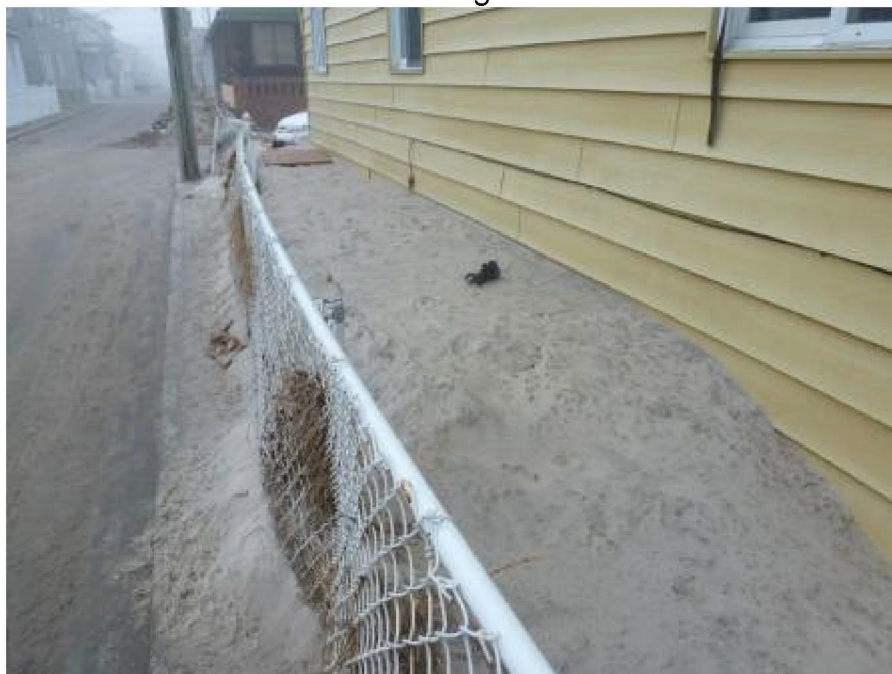
Photograph 8

View of the south wall of the building.

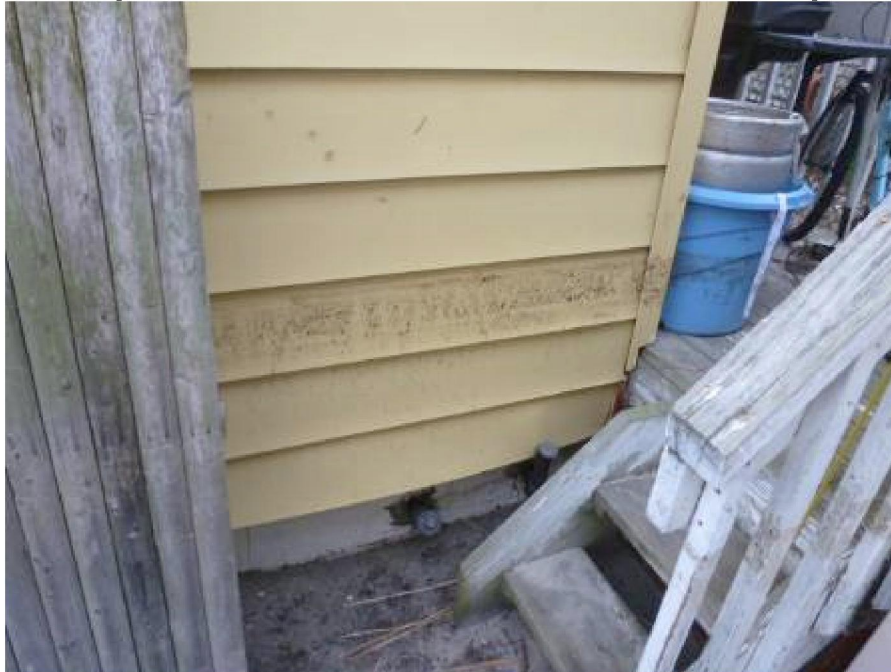
Photograph 9

View of high water marks on northeast corner of the building.

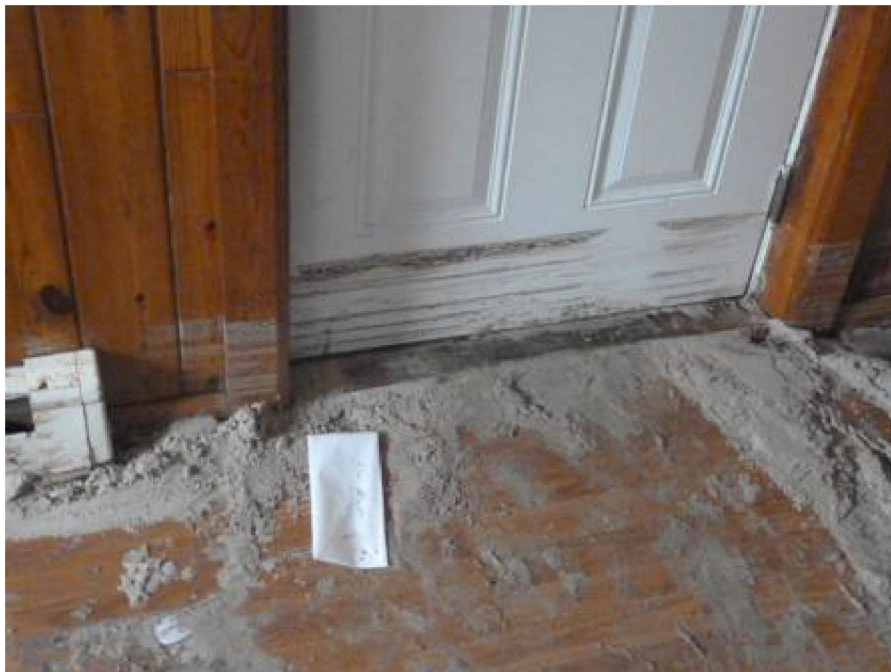
Photograph 10

View of main entrance door with high water marks as seen from inside. Note the sand on the floor.

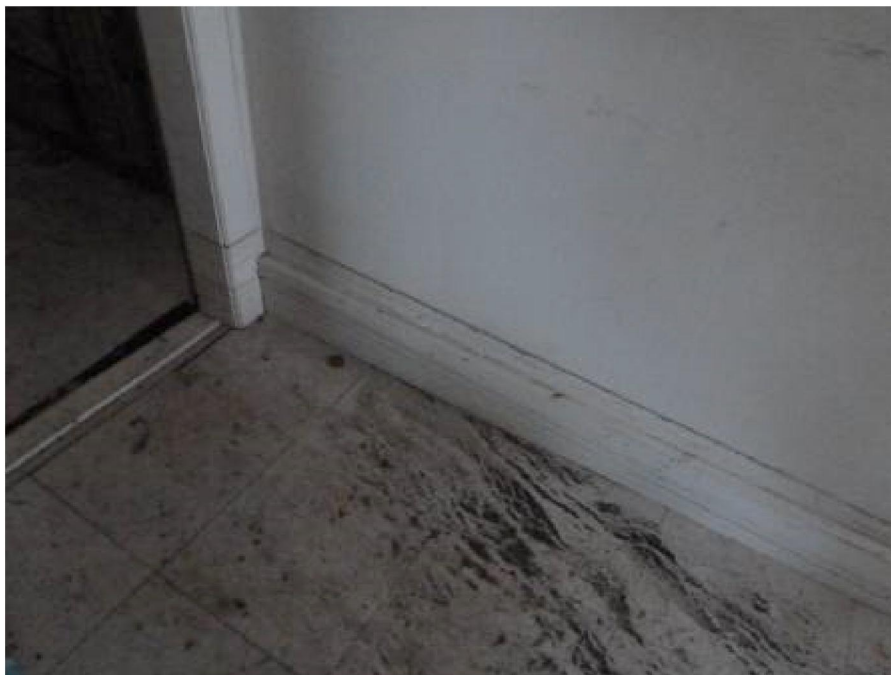
Photograph 11
View of wall in kitchen.

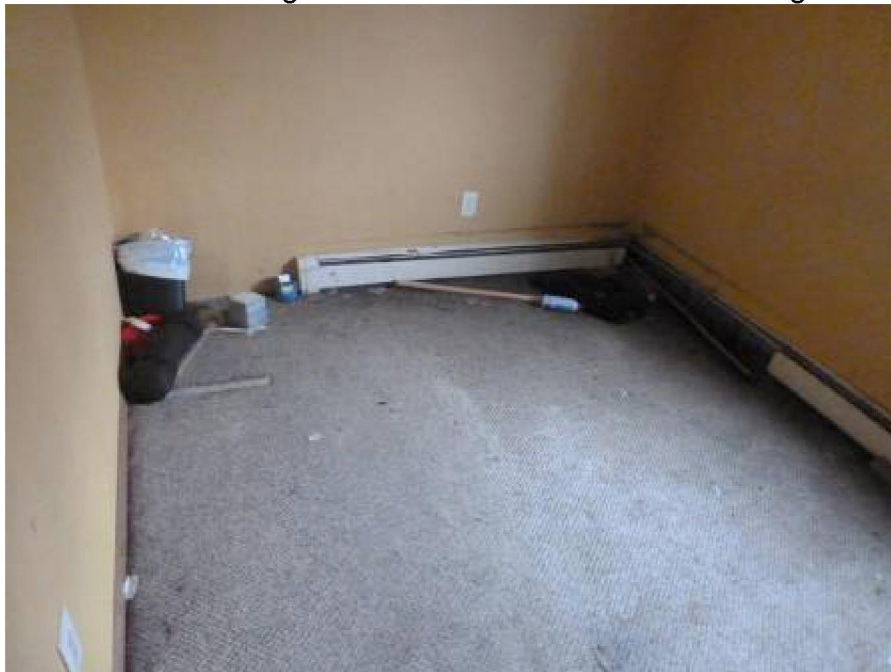
Photograph 12
View of bedroom along south and east walls of the building.

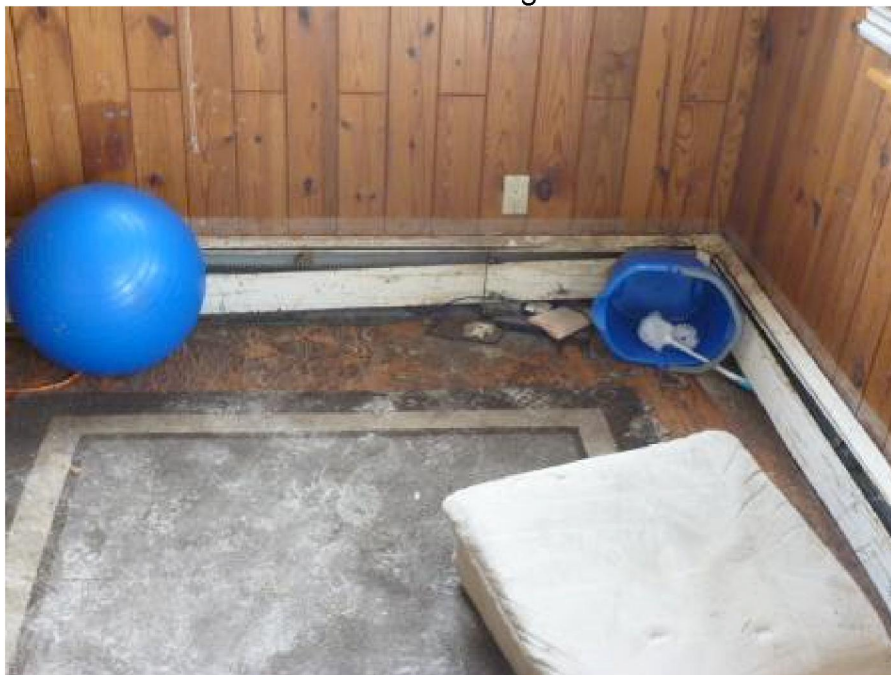
Photograph 13
View of southwest corner of the building.

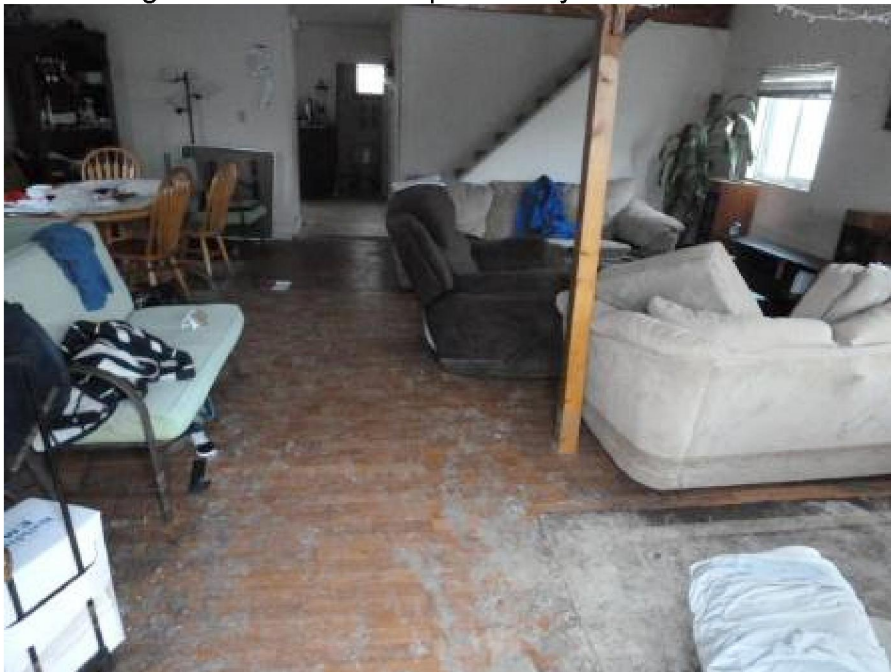
Photograph 14
View of living room with sand deposited by the recent flood event.

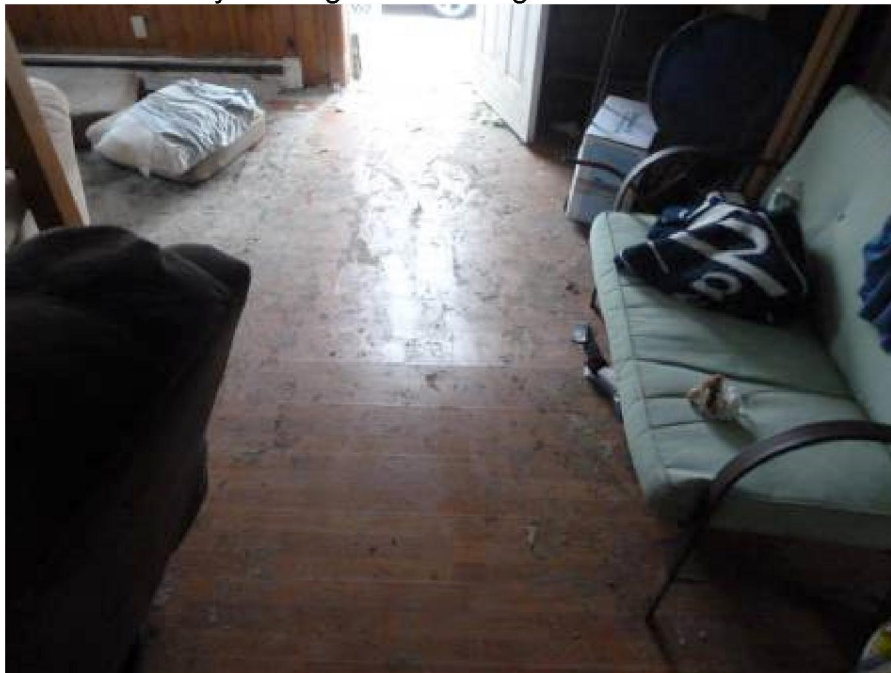
Photograph 15

Within the interior living area of the building, high water marks on the inside of the building were visible on various wall surfaces that were measured to be approximately 6 inches above the floor. Approximately half of the living room floor closest to the west wall yielded noticeably when walking on it. We noted a localized high ridge in the floor near central portions of the living room that was oriented parallel to the west wall. We performed relative elevation measurements of the floor surfaces within the interior living area of the building using an electronic relative elevation measuring device. The measured elevations of the floor along the south wall ranged from 2.7 inches below (in the south-east corner of the building) to 3.5 inches below the reference point in the middle of the building. The measured elevations of the floor along the north wall ranged from 1.7 inches (in the north-west corner of the building) below the reference point in the middle of the building to 1.4 inches above (in the middle of the north wall) the same reference point. The floor elevations can be characterized as sloping downward from northeast towards the southwest.

View of noticeably leaning floor in living room.

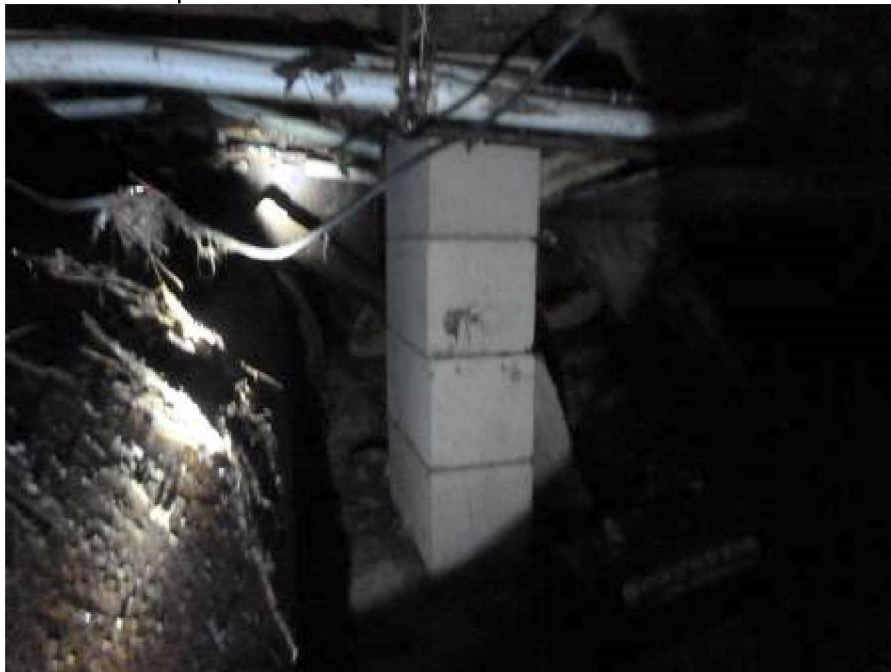
Photograph 16

View of crawlspace as seen from north-east.

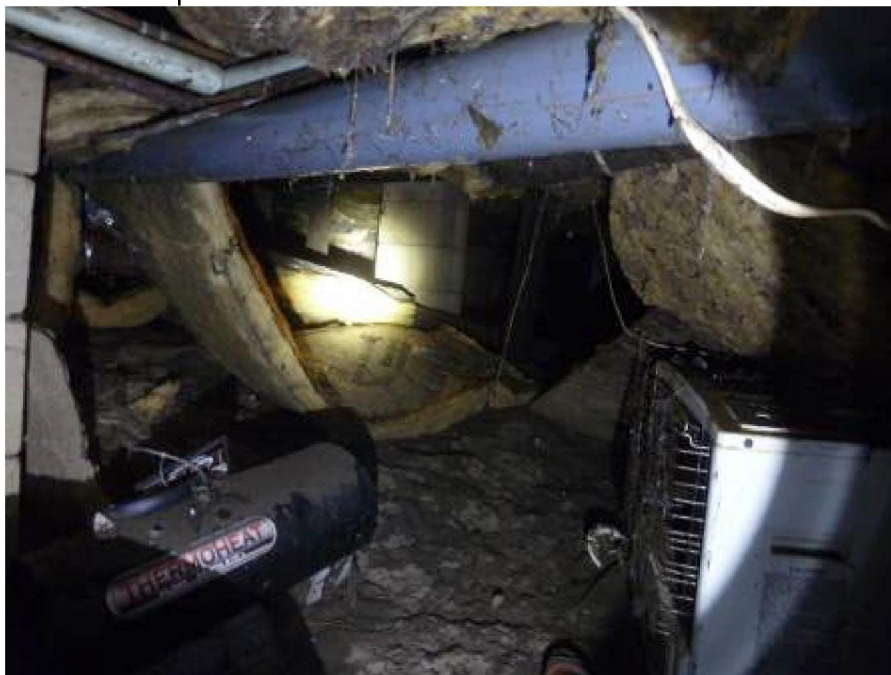
Photograph 17

View of crawlspace as seen from north-east.

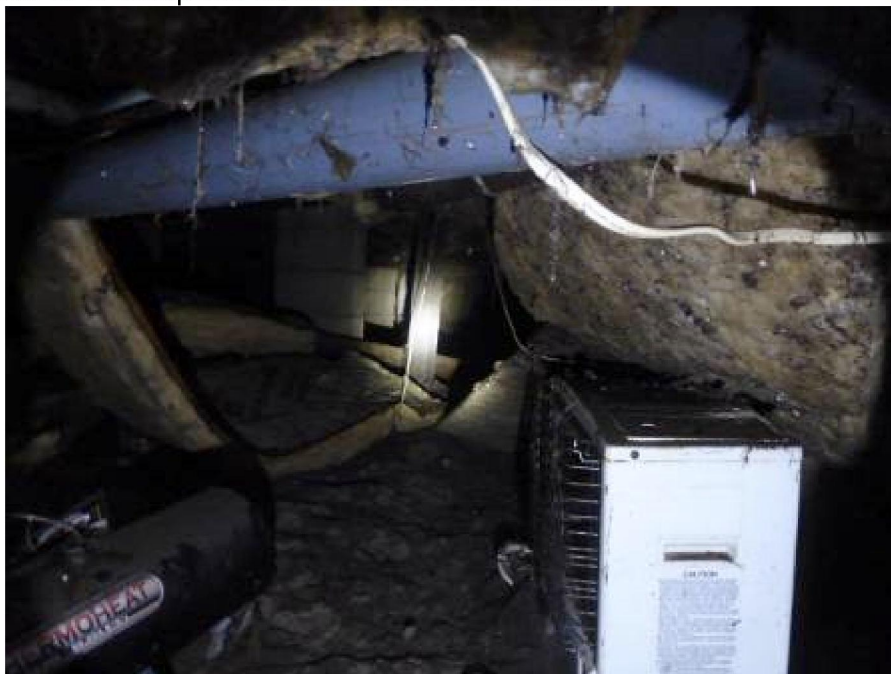
Photograph 18

View of crawlspace as seen from north-east.
